Technical Report 61

Noosa River entrance channel dynamics

**Steven Chamberlain
Rodger Tomlinson**

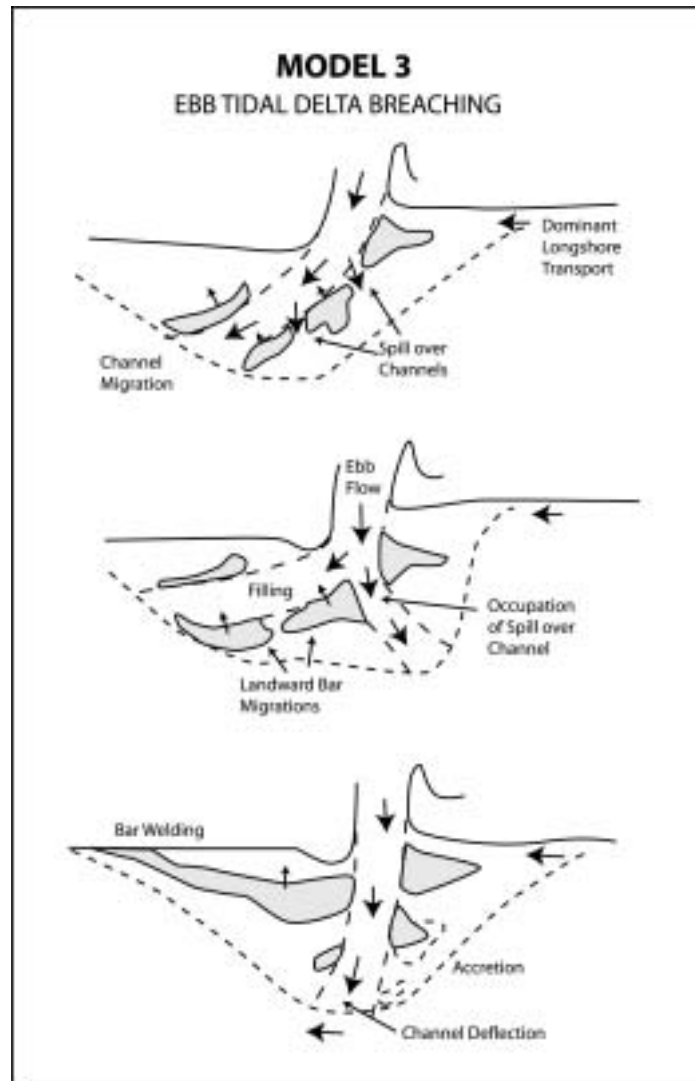
Figure 3. Model 3 of inlet sediment bypassing proposed by FitzGerald *et al.* (1978 cited in FitzGerald, 1988)

Bypassing sand by breaching of ebb-tidal deltas occurs at inlets that have a stable inlet throat position but a main channel that is able to migrate (Figure 3). A dominant longshore transport direction results in a preferential accumulation of sediment on the updrift side of the ebb-tidal delta. This in turn causes the main ebb channel to be deflected. Migration of the main ebb channel may continue until it interferes with the downdrift beach, resulting in erosion of the shoreline on this side. Such a configuration is hydraulically inefficient and results in the inlet taking a more direct route to sea through a spillover channel. This process may occur gradually or, in the case of a storm event, catastrophically when the scour

potential of the ebb jet has been increased by floodwaters. Once the delta has been breached, the major portion of flow will pass through this new channel and the abandoned channel will gradually fill. The result of this process is the bypassing of a large volume of sand that was previously stored in the ebb-tidal delta (FitzGerald, 1988).
